**HISTORICAL DATA REVIEW AND SITE ASSESSMENT  
ON  
TMDL INVESTIGATION FOR BACTERIA IN CORPUS CHRISTI BAY BEACHES**

**Texas Commission on Environmental Quality  
Total Maximum Daily Load Program  
P.O. Box 13087  
Austin, Texas 78711-3087**

**July 2011**

**TAMU-CC-1104-CCS**

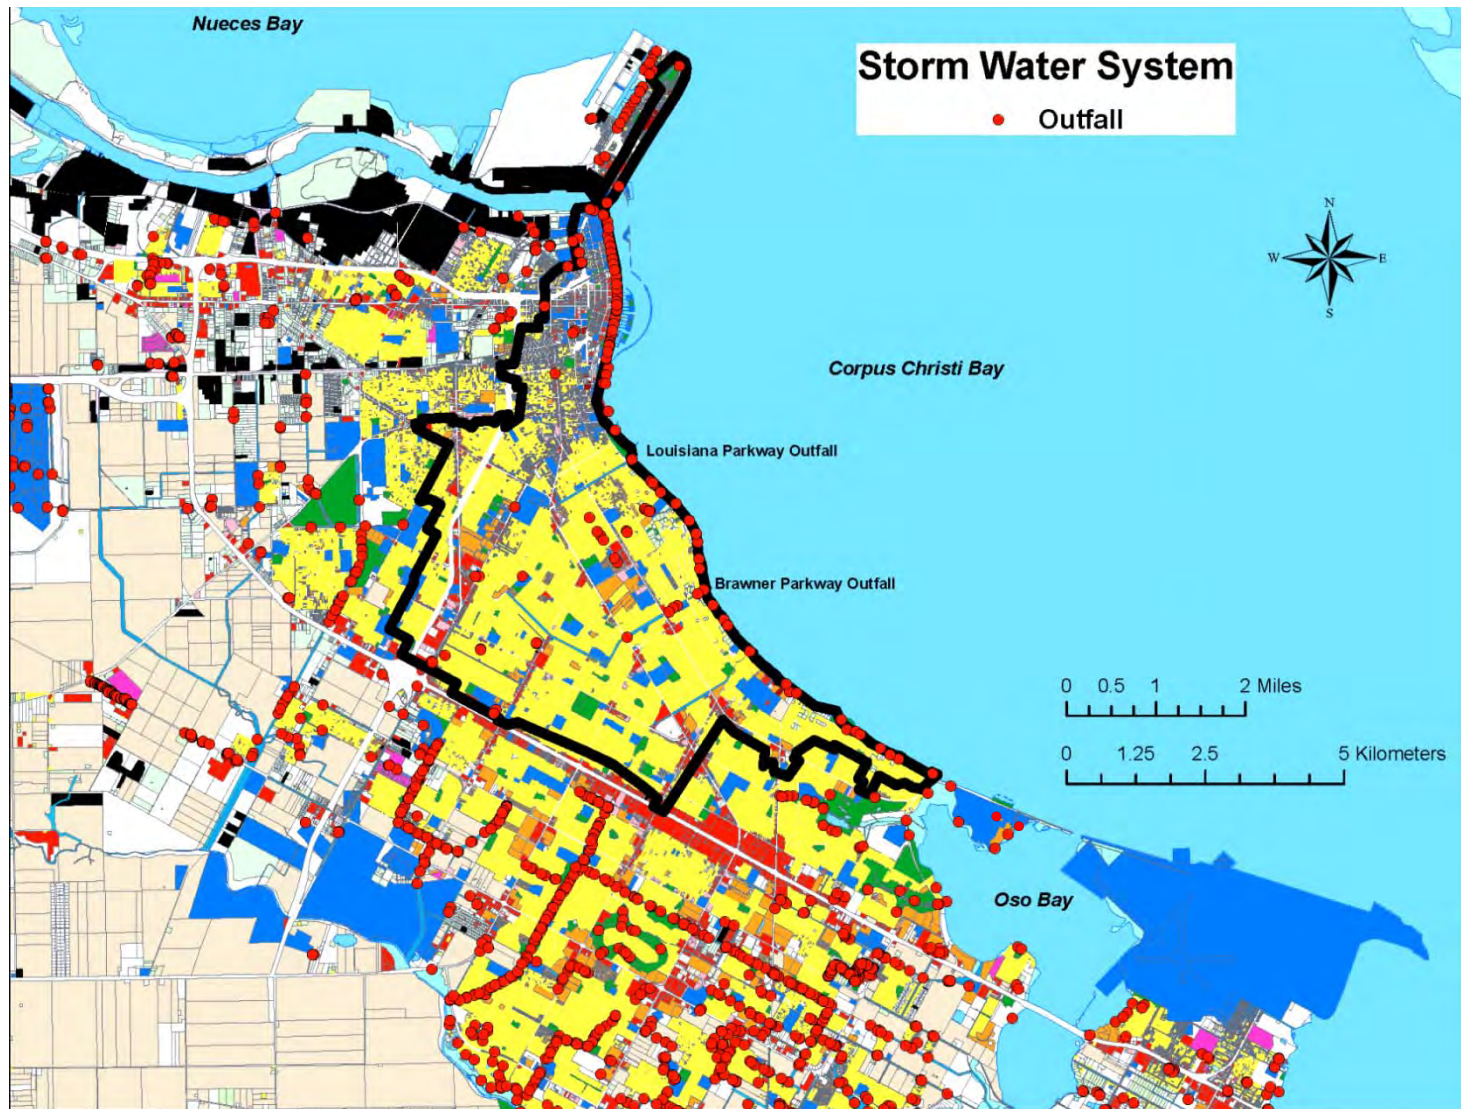
Fig. 2.3. Location of storm water outfalls located within the Corpus Christi Bay Storm Water Drainage Basin, basin area outlined in black (City of Corpus Christi 2011).

Analysis of outfall locations within the Corpus Christi Bay Basin shows approximately 70 active storm water outfalls located in the project area that drain into Corpus Christi Bay along the bay front (Fig. 2.3). The largest are the Brawner Parkway outfall at 3.6 x 3.4 m (12.0 x 11.0 ft.) located just south of Ropes Park and the Louisiana Parkway outfall at Cole Park, which is 3.4 x 2.9 m (11.0 x 9.5 ft.) (Fig. 2.3 and Fig. 2.4). Numerous other outfalls range in size from small diameter pipes up to the larger sizes stated above.

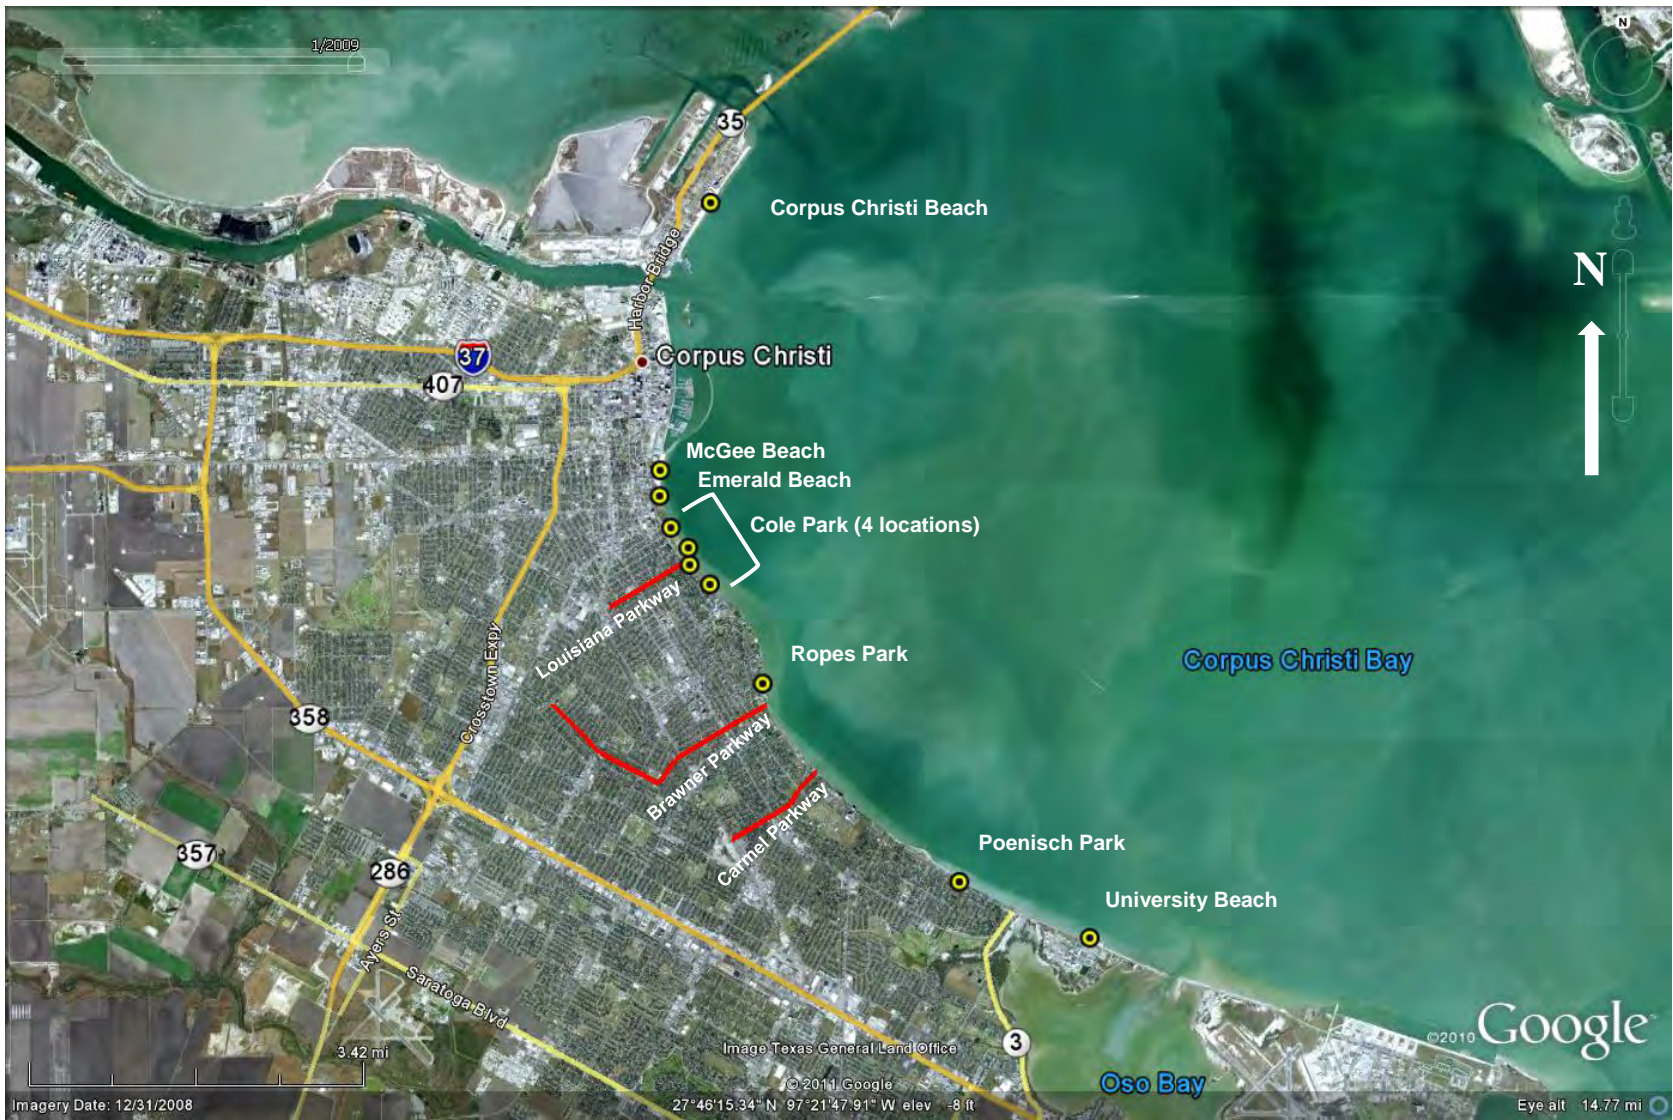
Fig. 2.4. Aerial photo depicting Corpus Christi Bay Beaches TMDL sampling locations and three major drainage ditches at Louisiana Parkway, Brawner Parkway, and Carmel Parkway. Retrieved on April 5, 2011 from Google Earth.

The following descriptions reflect information observed on site visits made to the location during the planning stages of this project or obtained through city records. These areas represent 10 project sampling locations (Fig. 2.4) that coincide with existing stations sampled by the Texas Beach Watch Program.

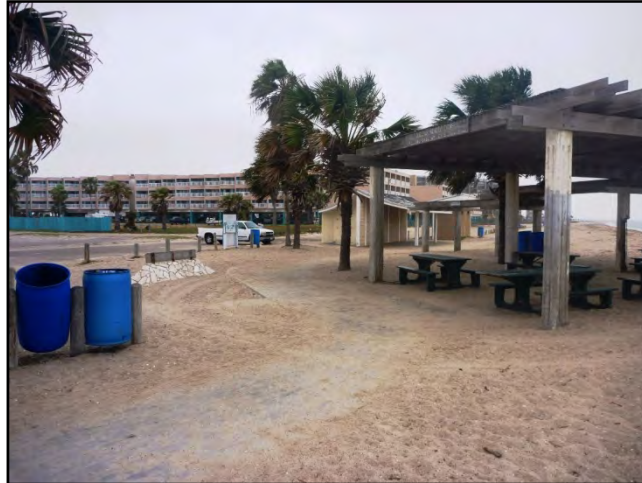
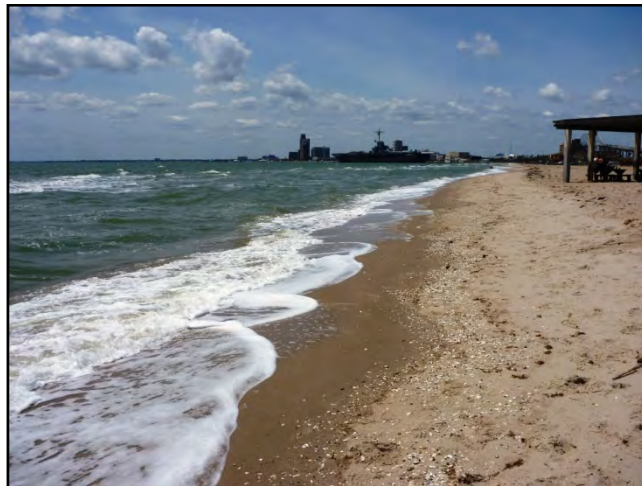
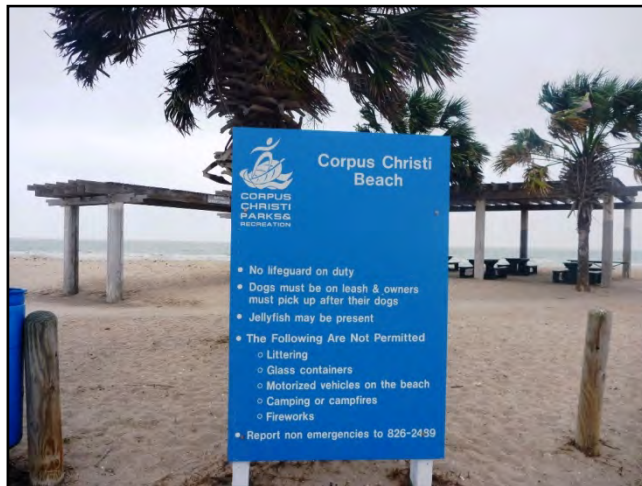
Fig. 2.5. Views of Corpus Christi Beach at Surfside Park with A) pavilion and bathroom facilities, B) signage, and C) beach looking south towards the U.S.S. Lexington and downtown Corpus Christi.

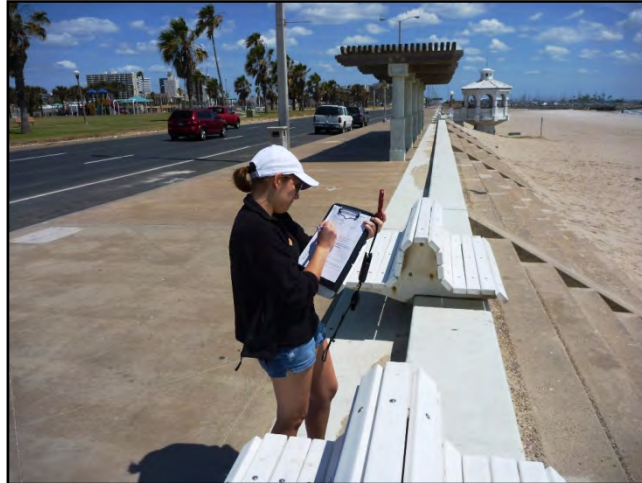
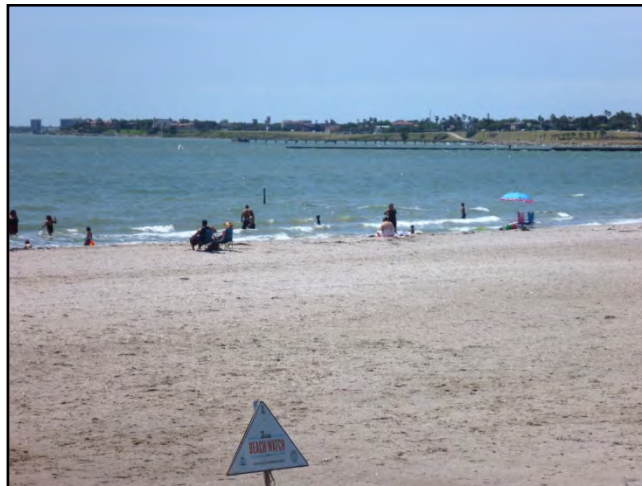
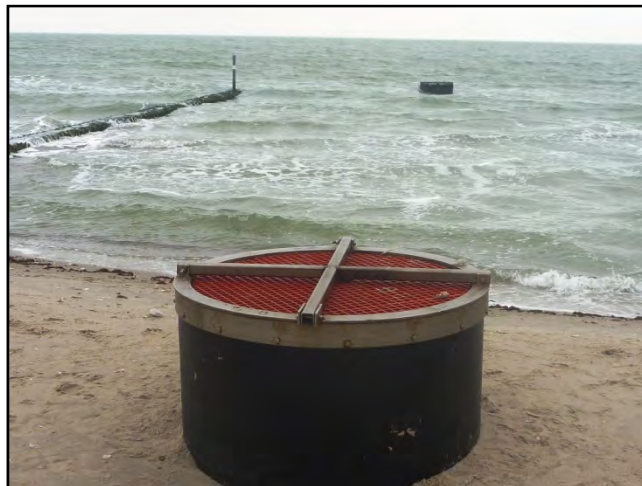
**Beach:** The approximate length of the beach is 535 m (1765ft.). The intertidal sandy slope into Corpus Christi Bay is approximately 115° - 120° (Fig. 2.7B). Orange hazard fencing was present on the beach but no sign was present to identify caution. The fencing was in line with the outfall pipe.

Fig. 2.7. Views of McGee Beach with A) street side parking with benches and gazebos, B) beach view, and C) storm water outfall drains.

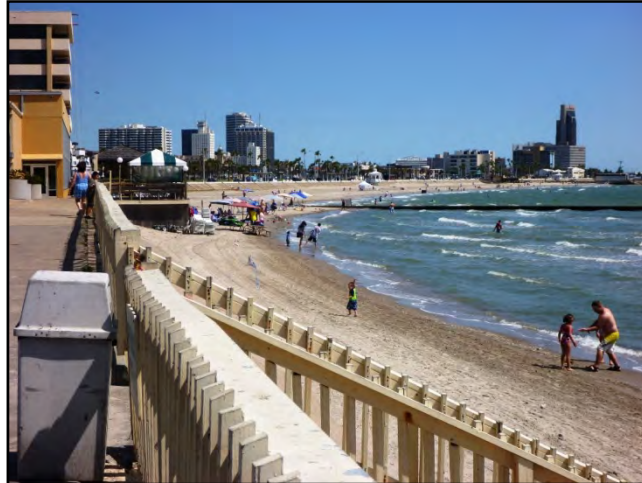
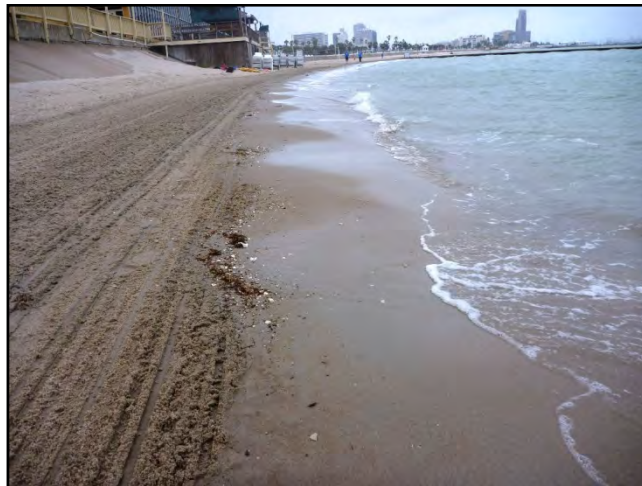
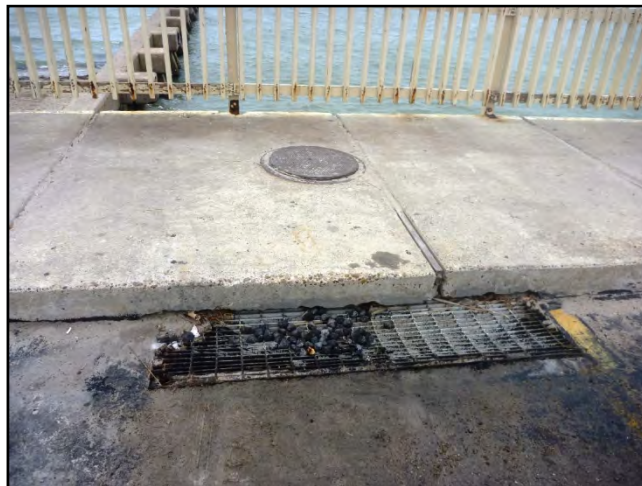
Fig. 2.9. Views of Emerald Beach with A) beach view looking northwest with McGee Beach in background, B) beach raking tracks, and C) storm drain.

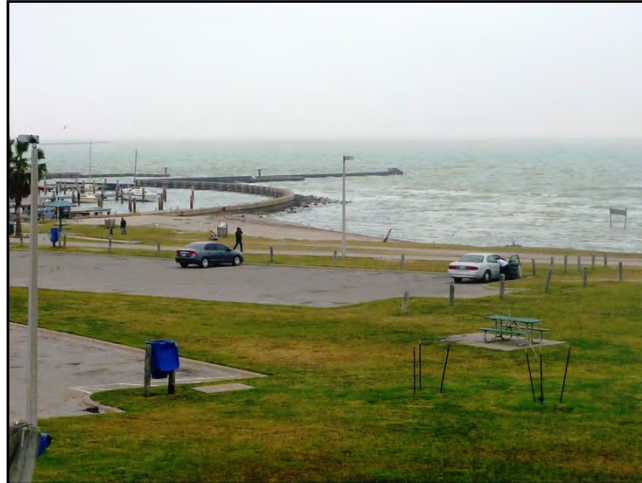
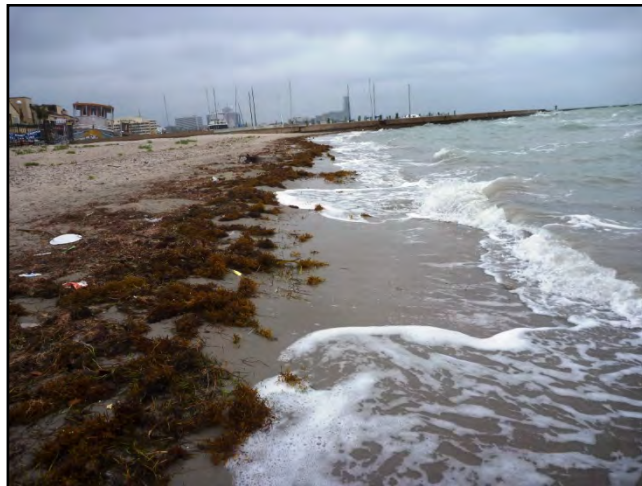
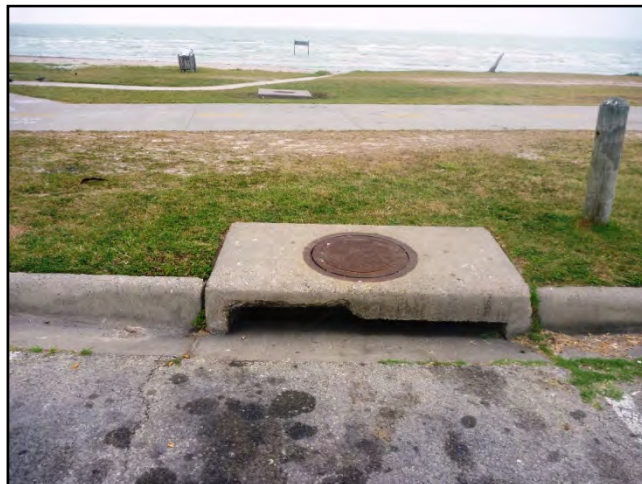
Fig. 2.11. Views of Cole Park North with A) parking lot and beach view, B) beach debris, and C) storm water drain in parking lot with additional drain in park in background.

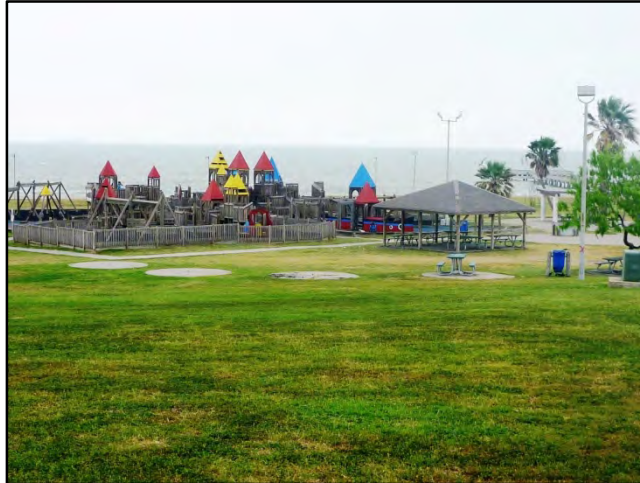
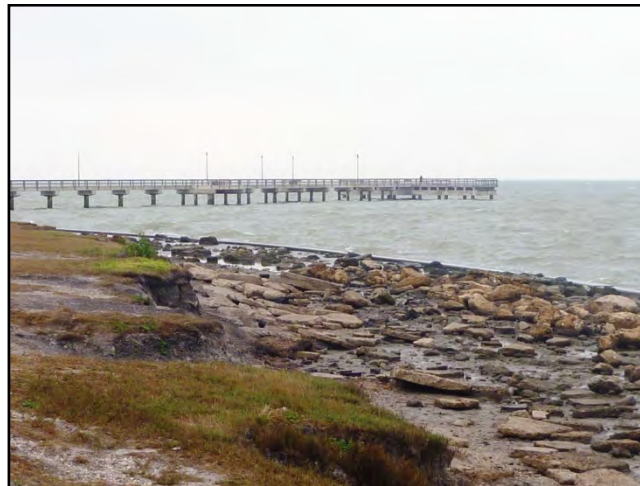
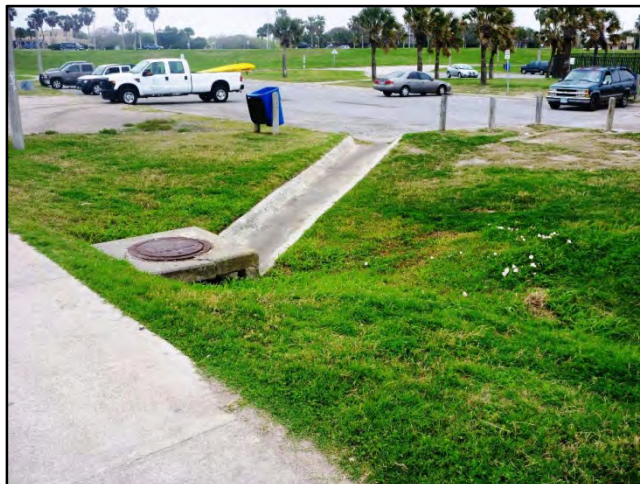
**Beach:** There is no beach. The shoreline is a concrete bulkhead with large rocks and obstructions. High wave energy often makes it unsafe to enter the water at this location (Fig. 2.13B).

Fig. 2.13. Views of Cole Park Pier area with A) “Kids Place” playground, B) bulkhead area with fishing pier in background, and C) storm water drain in parking lot.

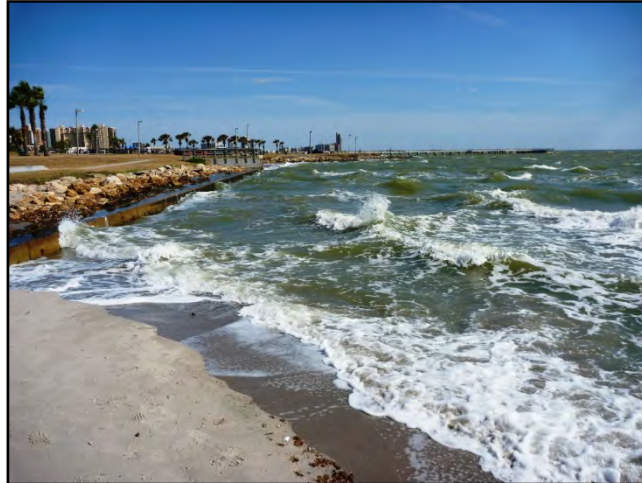
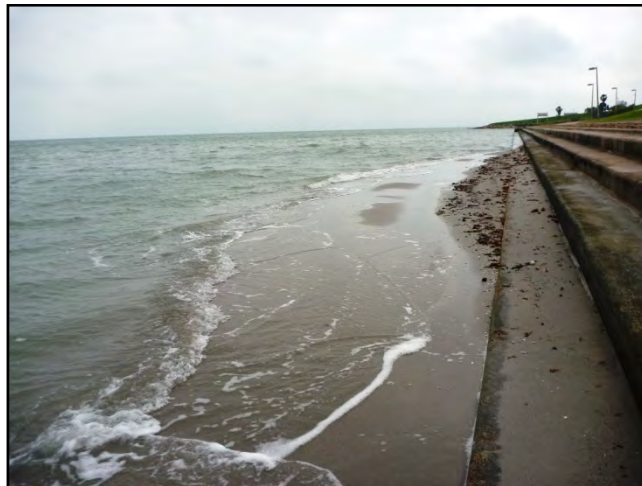
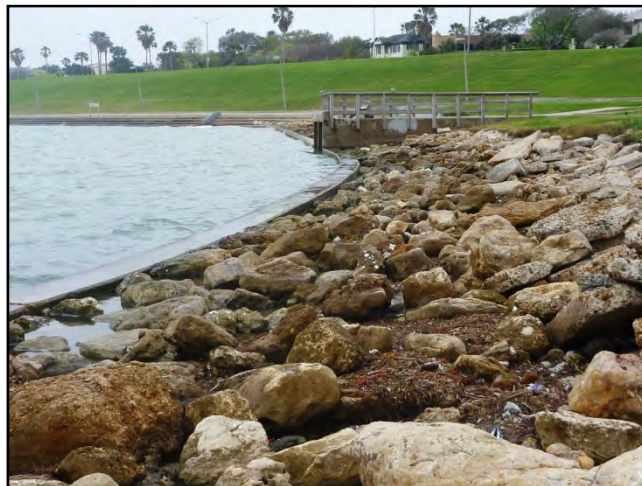
**Beach Access:** There is no beach access at this site except to a small sand spit that is dynamic in nature due to tides and currents (Fig. 2.15B). Access to the sand spit is via a paved path that leads to the concrete seawall steps. Caution is noted when accessing the water because the seawall concrete steps may be slippery and covered with algae.

Fig. 2.15. Views of Cole Park at Louisiana Outfall area with A) shoreline bulkhead with outfall in near ground and fishing pier in foreground, B) small sand spit access area that migrates down shoreline depending on wind and water currents during the year, and C) Louisiana Parkway storm water outfall.

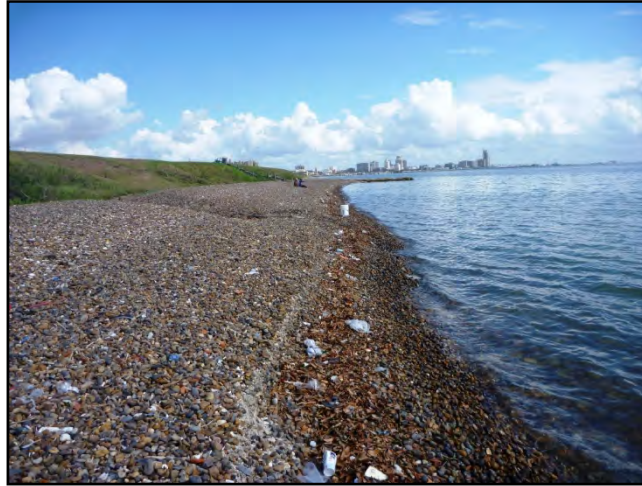
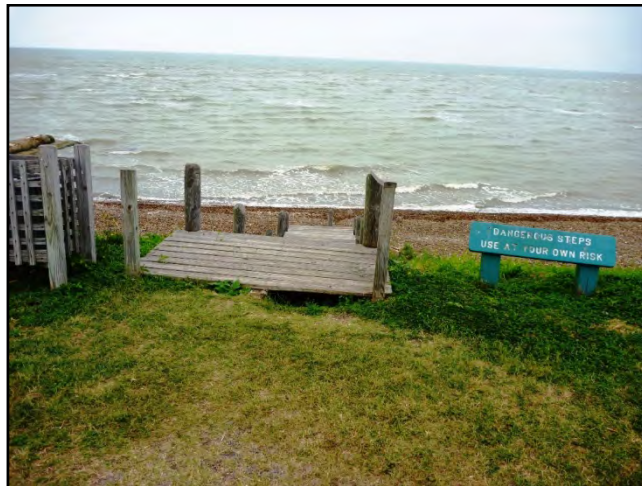
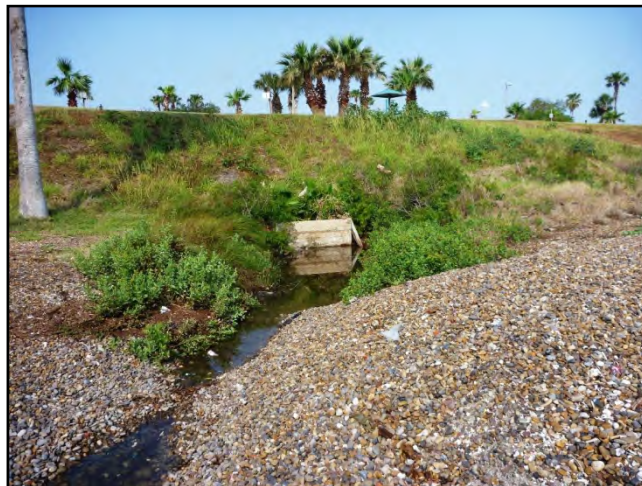
**Beach:** Total beach length is approximately 548 m (1800 ft.) with approximately 107 m (350 ft.) surveyed for this project. Substrate consists of rubble rock (Fig. 2.17A) with an intertidal slope into Corpus Christi Bay of approximately 115°. Caution was noted when accessing the water due to large concrete material in the water in some locations.

Fig. 2.17. Views of Cole Park at Oleander Point with A) rubble rock beach shoreline, B) access steps with signage, and C) one of the three storm water outfalls with stagnant water pools.

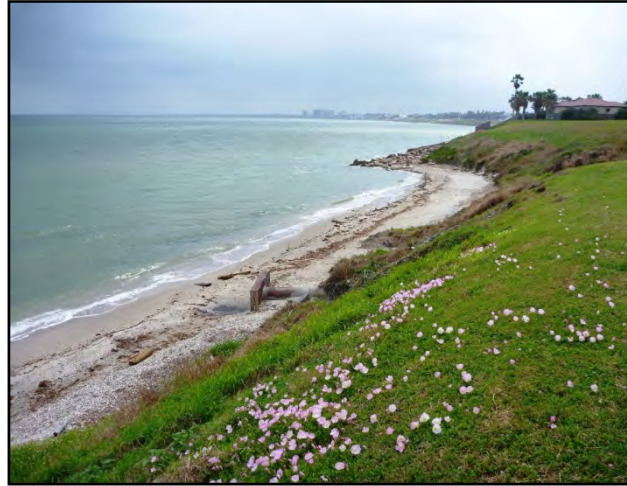
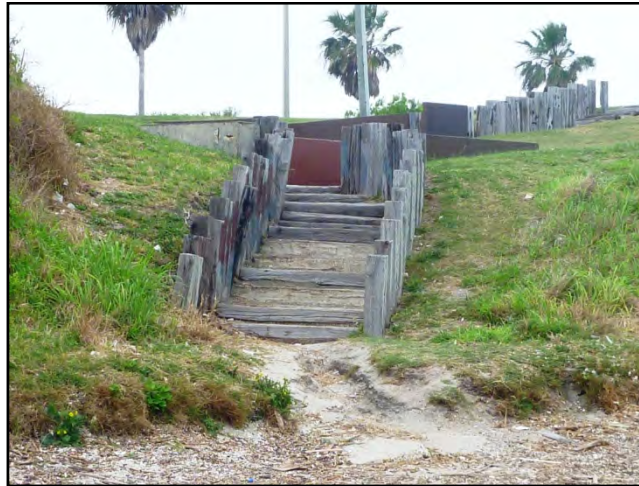
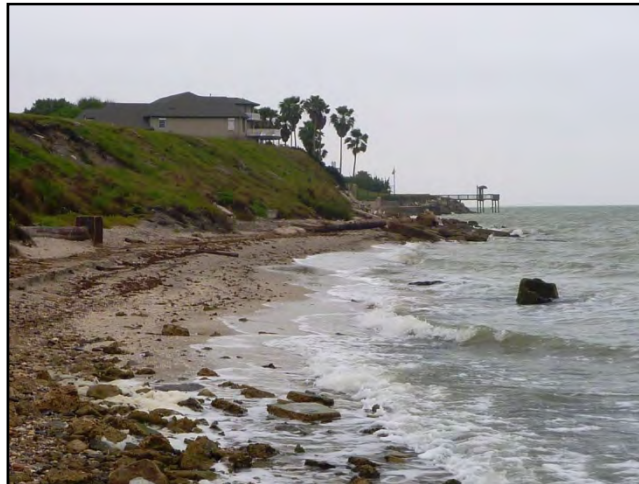
Fig. 2.19. Views of Ropes Park with A) sandy part of shoreline, B) access steps with signage, and C) storm water outfall and concrete rubble portion of beach in foreground and background with concrete debris in water clearly visible.

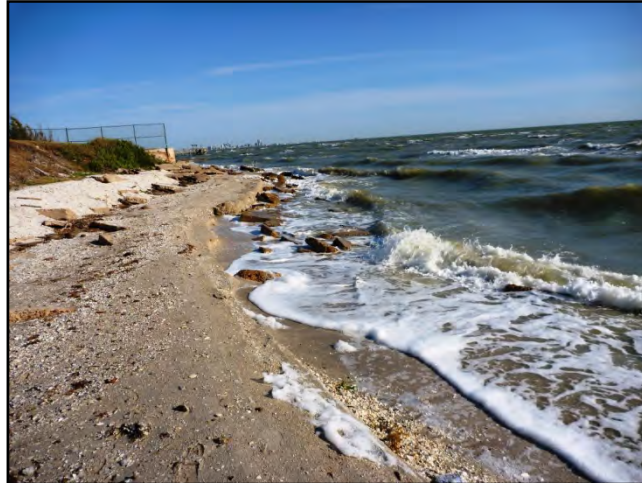
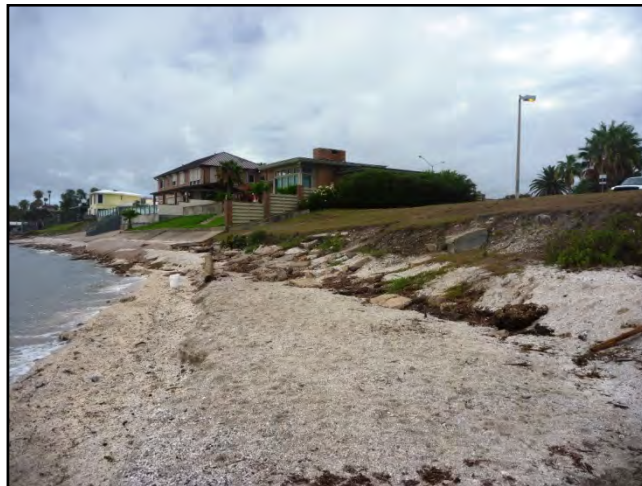
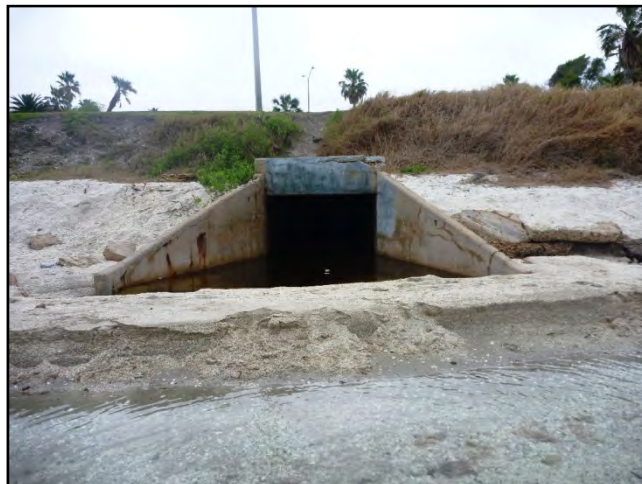
Fig. 2.21. Views of Poenisch Park with A) sandy and concrete rubble shoreline looking northwest towards downtown Corpus Christi, B) shoreline looking southeast with typical bank profile, and C) storm water outfall with stagnant pool of water.

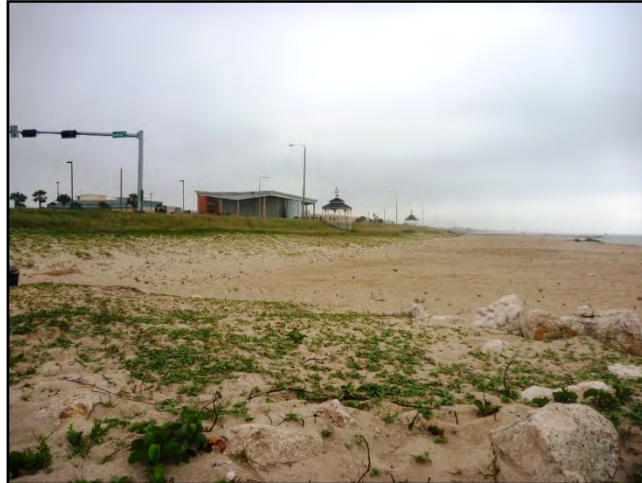
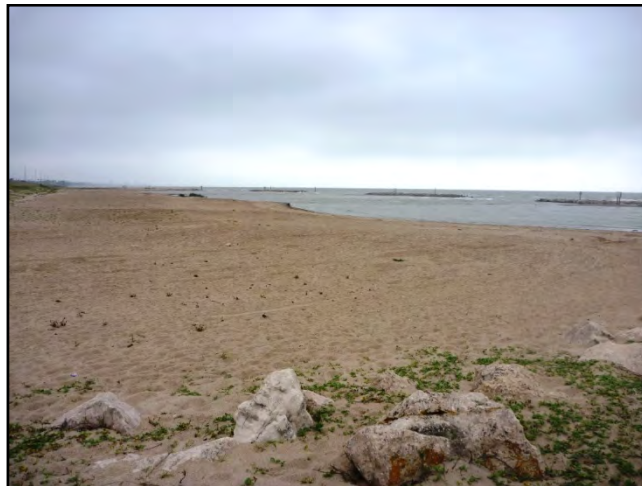
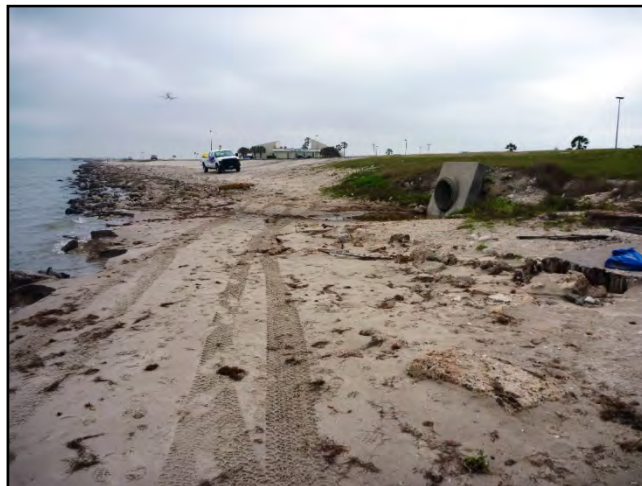
Fig. 2.23. Views of University Beach with A) gazebos and slope access in distance, B) view of beach looking northwest, and C) storm water outfall and parking on southeast end just outside of beach area.

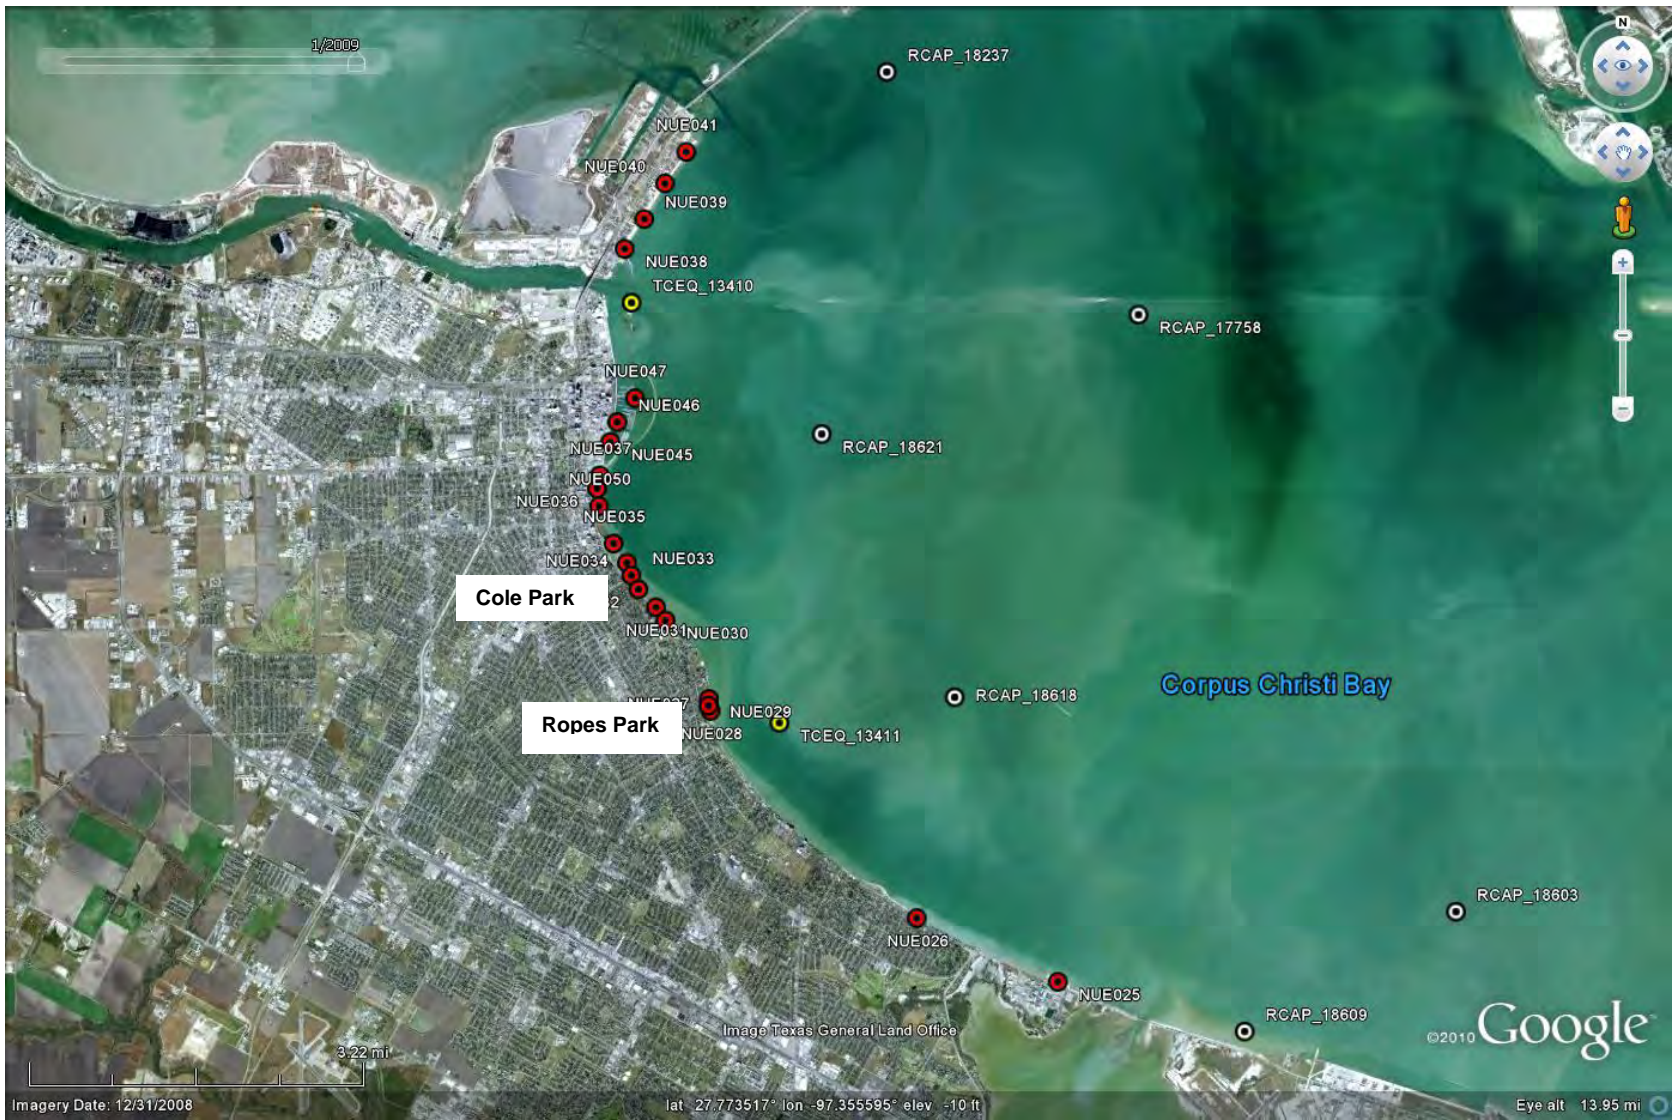
Fig. 3.1. Location of TCEQ stations (yellow dots), RCAP stations (white dots), and Texas Beach Watch stations (red dots) reviewed for enterococci data. Retrieved on July 5, 2011 from Google Earth.

One exceedance of the criteria occurred in August 2002 at Station 18327 located at the interface of Nueces Bay and Corpus Christi Bay (Fig. 3.1), where the value recorded was 324 MPN/100 ml and was likely due to excessive inflows from the Nueces River that began in July 2002 and were still ongoing during sampling. Concentrations at all other Corpus Christi Bay stations were <10 MPN/100 ml except for one station located in the southern portion of the segment, north of the JFK Causeway (segment boundary) in the Upper Laguna Madre, where the concentration was 41 MPN/100 ml.

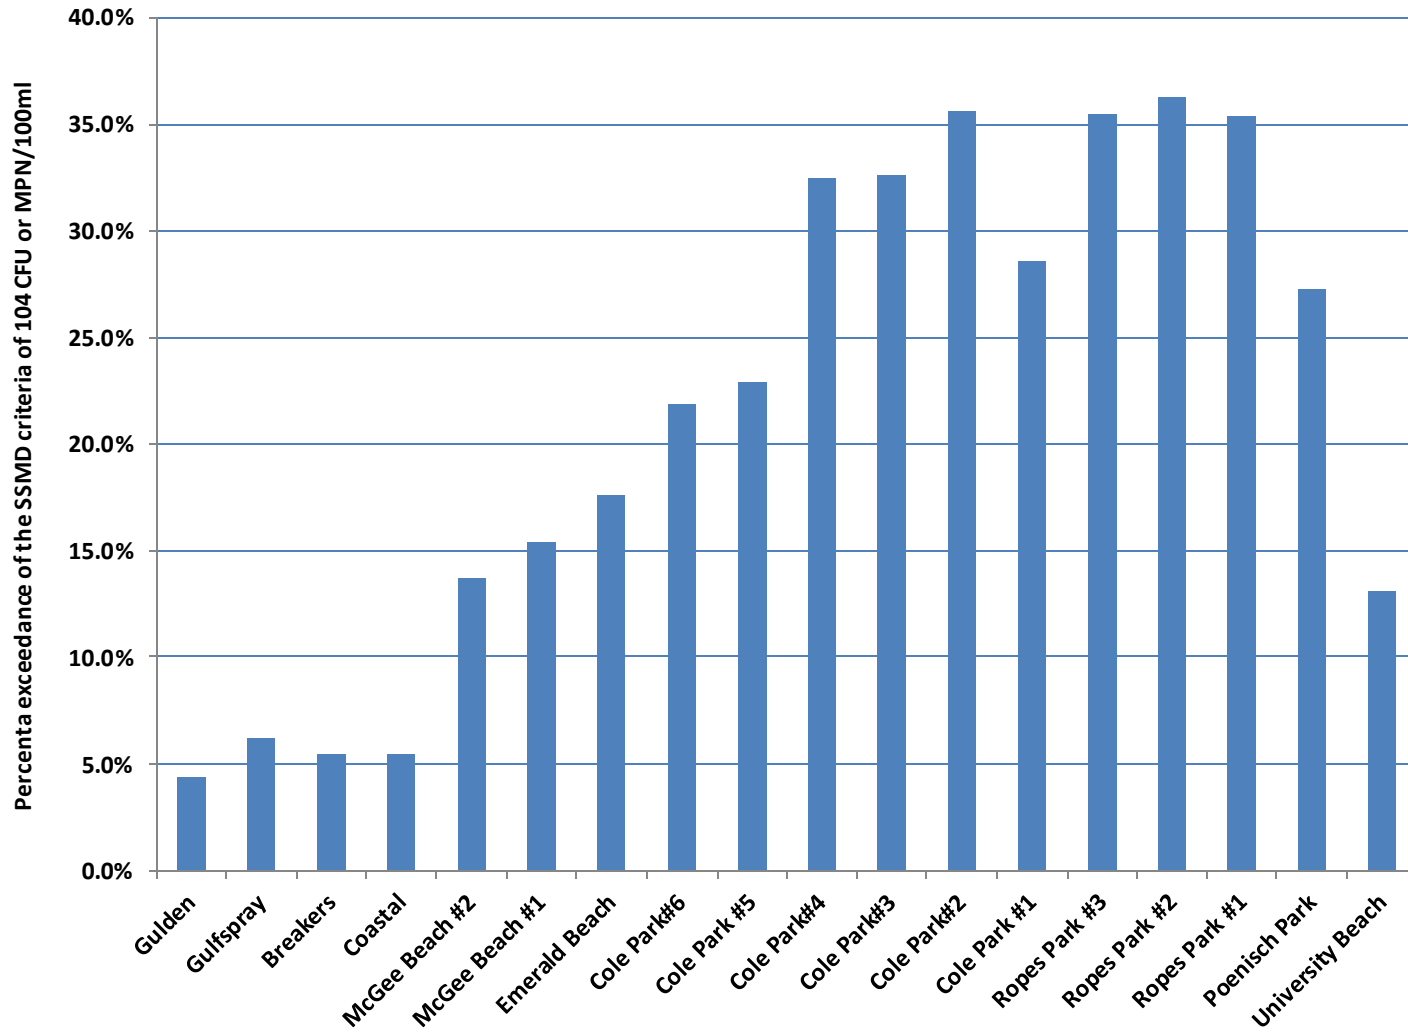
Fig. 3.2. Percent exceedance of the 104 CFU or MPN/100 ml criteria for averaged sample data from November 2003 through March 2011 at Texas Beach Watch locations in Corpus Christi Bay
